Executive Summary

Brannon Gearhart Park Study Area

3.0 Playground and Surrounding Area (Questions on this section can be directed to Marketa Murray at mata0013@yahoo.com)

4.0 Pond and Immediate Surroundings (Questions on this section can be directed to Del Grau at dlsash@q.com)

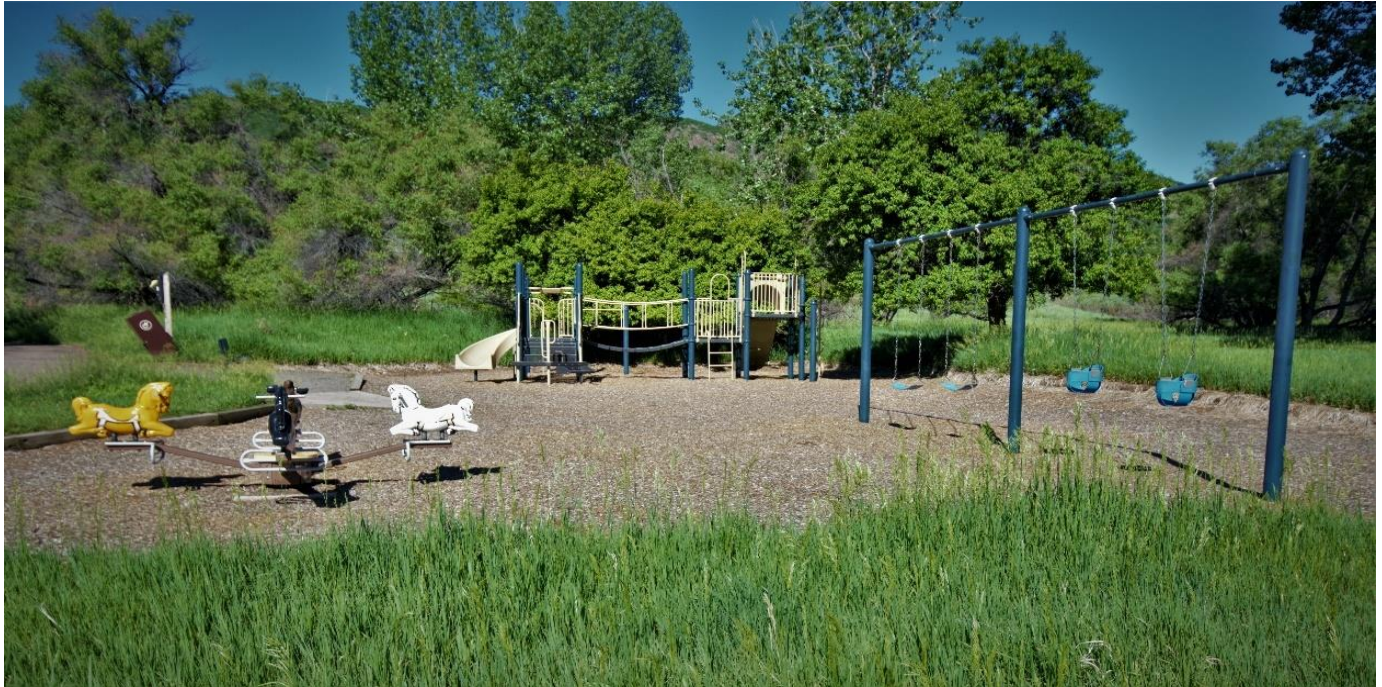
Existing playground looking west

The playground is approximately 30 years old and is in need of repair and is geared for toddlers and very young children. It is currently scheduled for an upgrade in 2024, and KCRMA reserved funding has been accumulating for a number of years. Approximately \$81,000 has been budgeted for this activity.

The playground consists of a climbing structure, a pony ride which is extremely popular with the residents, and four swings. The swing seats have been replaced over the years and are considered to be in good condition. The climbing structure is in need of repair and since there is limited shade, many of the features are extremely hot to the touch. This is particularly true of the ponies in the summertime. Engineered bark serves as a soft foundation to reduce the impact from falls.

The existing equipment should be repaired and the jungle gym set retrofitted with a shade structure. Since a shade structure over the ponies may not be feasible due to its high cost, consideration should be given to replacing the two darker colored ones with two lighter colored ones (e.g. white and yellow). The shade structure for the gym set should be as natural as possible, and no bright colors should be used. Since there is a large amount of space between the current equipment it is recommended a “Vippy” be added (see picture below). The existing engineered bark should be refreshed.

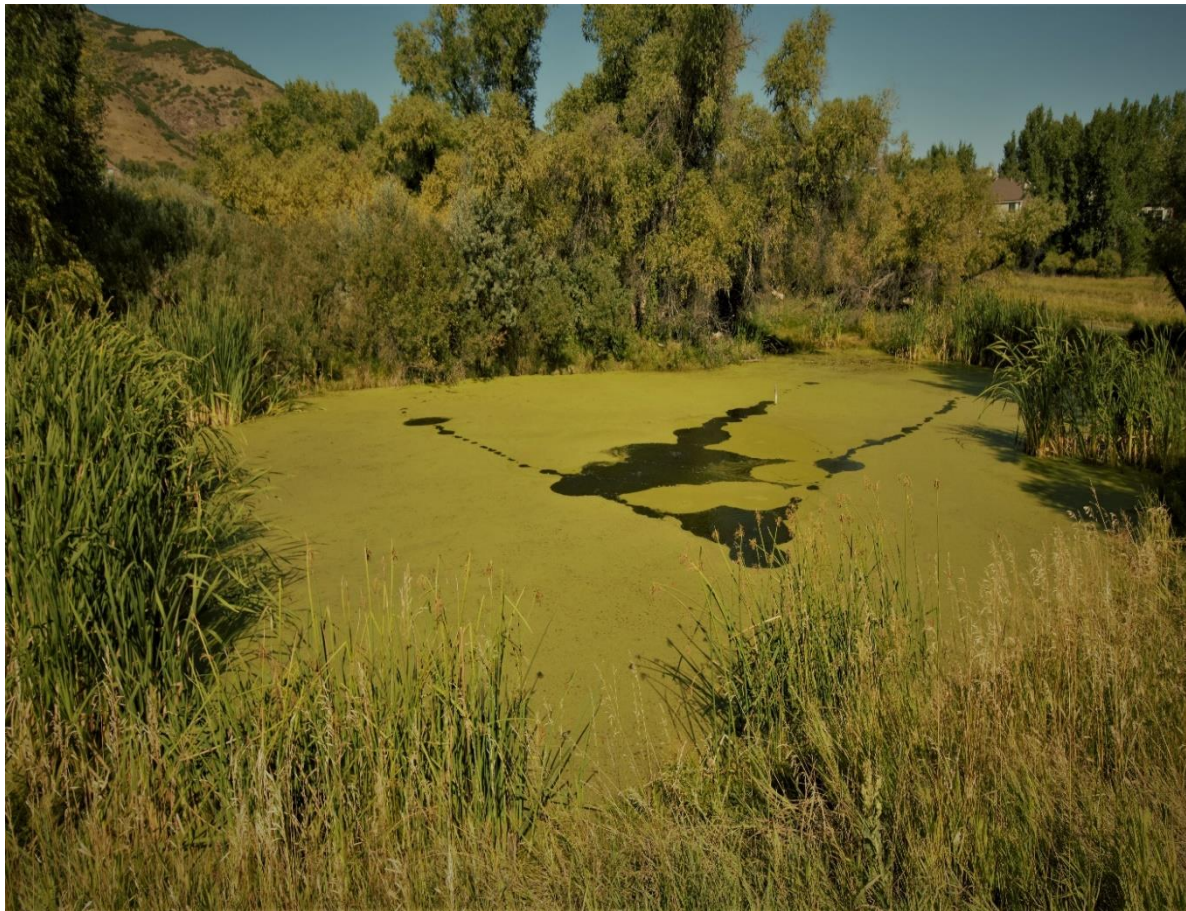
*Looking
north taken
in
September
2019*

The original inlet and discharge piping are in disrepair and the grate covering the discharge pipe is often clogged. There are clumps of cattails growing along the banks and they have grown in size over the past few years. Tall native grasses surround the pond on three sides. The northwestern bank is lined with native trees and shrubs. Despite its limitations, the pond continues to be a resource used by many. On summer days there are children fishing. In the spring, many residents admire the ducks that have returned to raise ducklings.

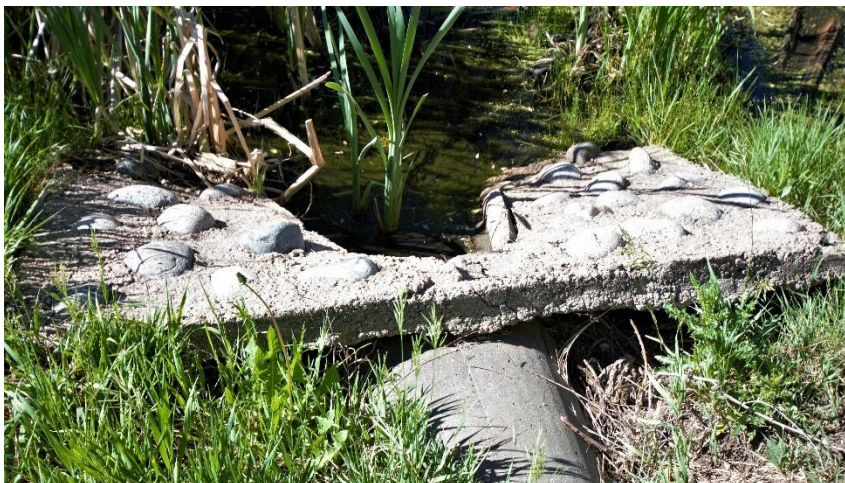
Inlet Repair

The inlet repair consists of (1) repairing the concrete connector pipe and (2) restoring the backing of the decorative rock face that has eroded away.

Assuming this activity is done during dredging operation the repair should simply consist of developing wooden forms and pouring concrete into the voids. Since the area around the inlet would be relatively dry this is an inexpensive solution. If it is done when the water level returns to its normal height additional forms and effort will be required.

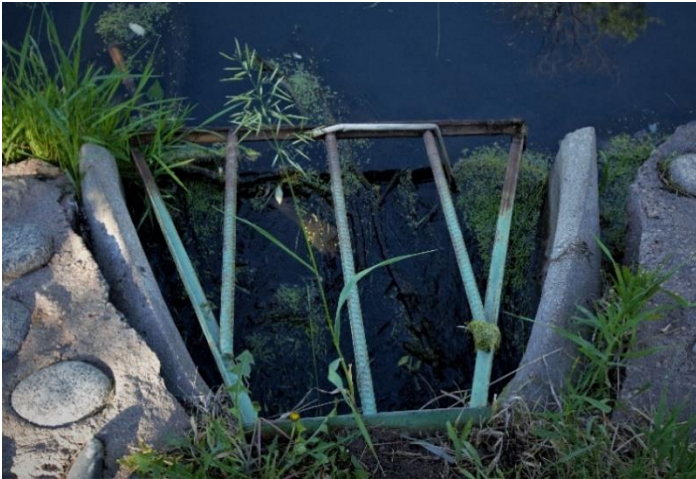
Outlet Repair

The outlet repair consists of (1) repairing the rebar grate which is loose and (2) restoring the backing of the decorative rock face that has eroded away.

Similar to the Inlet repair this work should be done during dredging operation. The added cost would be to connect the grate with rebar and embed the rebar into concrete poured for filling the voids.

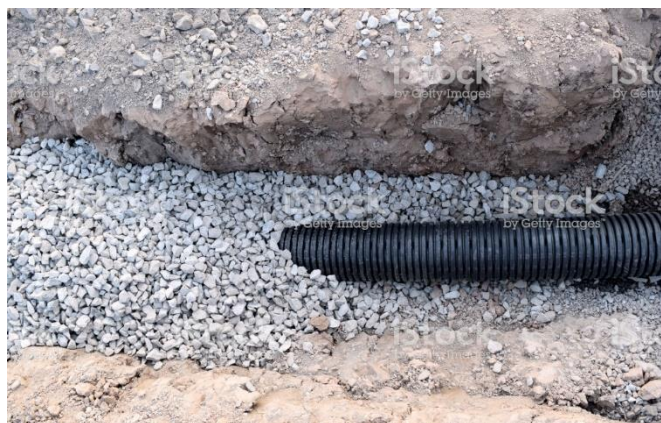
base of the manhole is filled with groundwater. A supervisor said that it is not unusual for groundwater to flow along the gravel “packing” which surrounds a sewer pipe and to accumulate near a manhole.

Gravel-packed Sewer Line

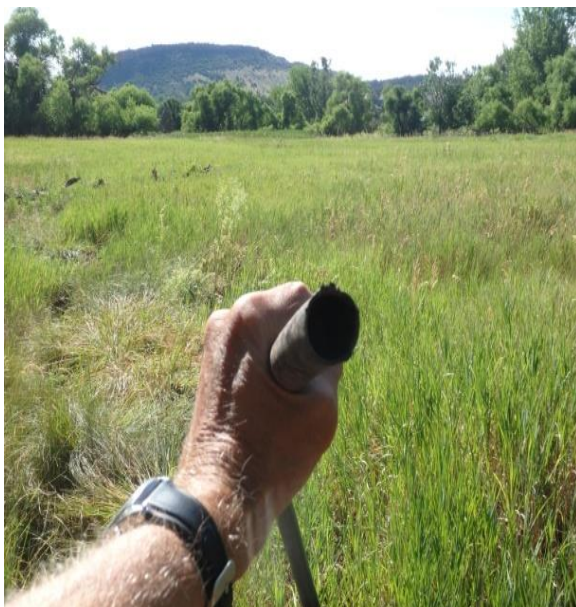
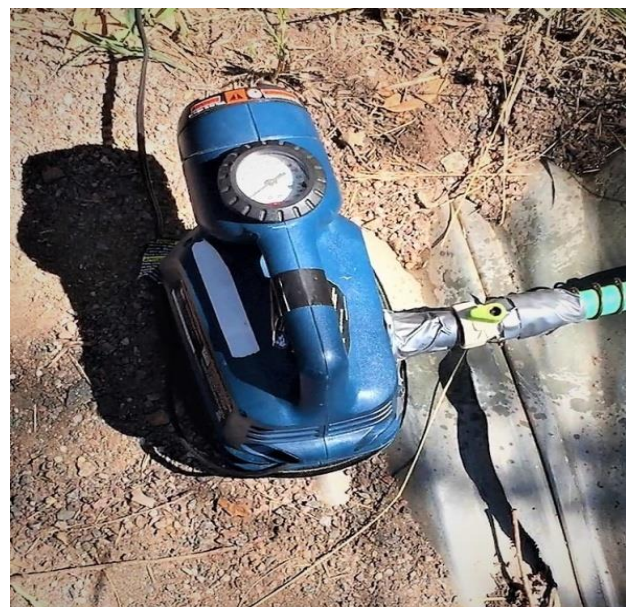
During the Task Force investigations, an old irrigation pipe was found half-buried in the northwest end of the meadow near the trail from Willowleaf Drive.

It was probably installed around 1990 to bring water from the Valley Parkway to a garden area in the center of the park. It leads into the center of the marsh. When the protruding section of the one-inch plastic line was cut and attached to a small electric pump, water from the marsh began flowing from the marsh out of the pipe. A bacterial test from CDPHE shows the water has zero e coli and only 100 parts per million of total coliform organics, within EPA limits for recreational water. This suggests that the old

irrigation line could be re-directed, extended to the south, and used to periodically supplement the pond or creek.

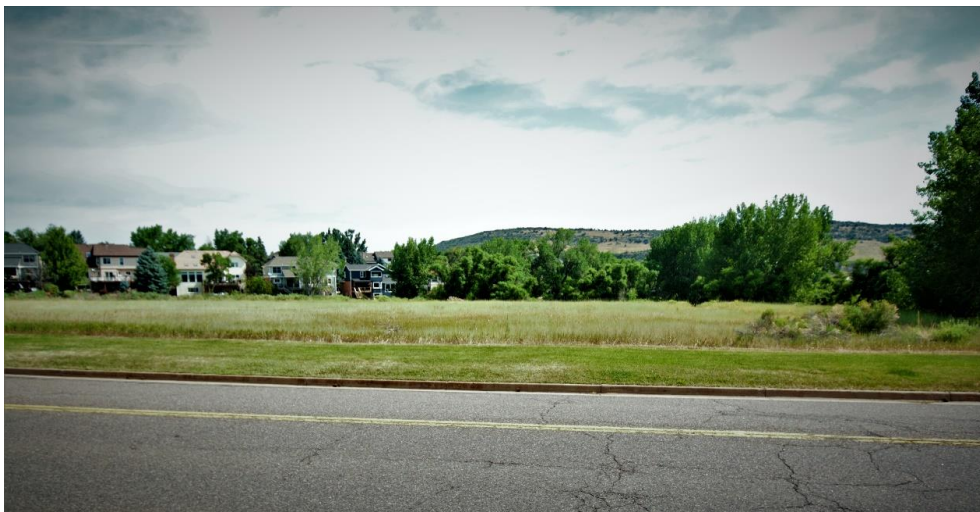
View from Valley Parkway – suggest expand mowed area by 40 ft.

The Master Association should direct staff to increase the mowed border along the Valley Parkway on the west side of the park to 40 feet to reduce the potential spread of wildfires.

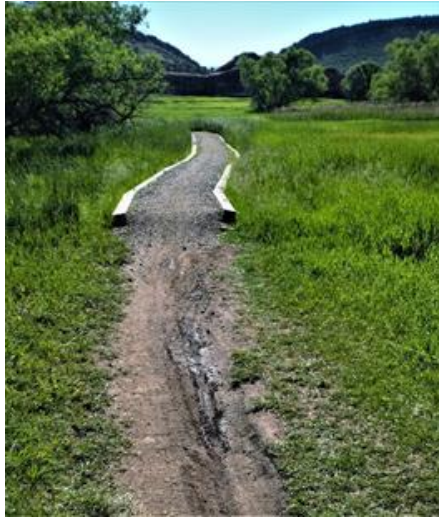
Turnpike recommended for widening
