BGP Task Force Report to KCRMA Board - Overview

BGP Task Force Report to KCRMA Board

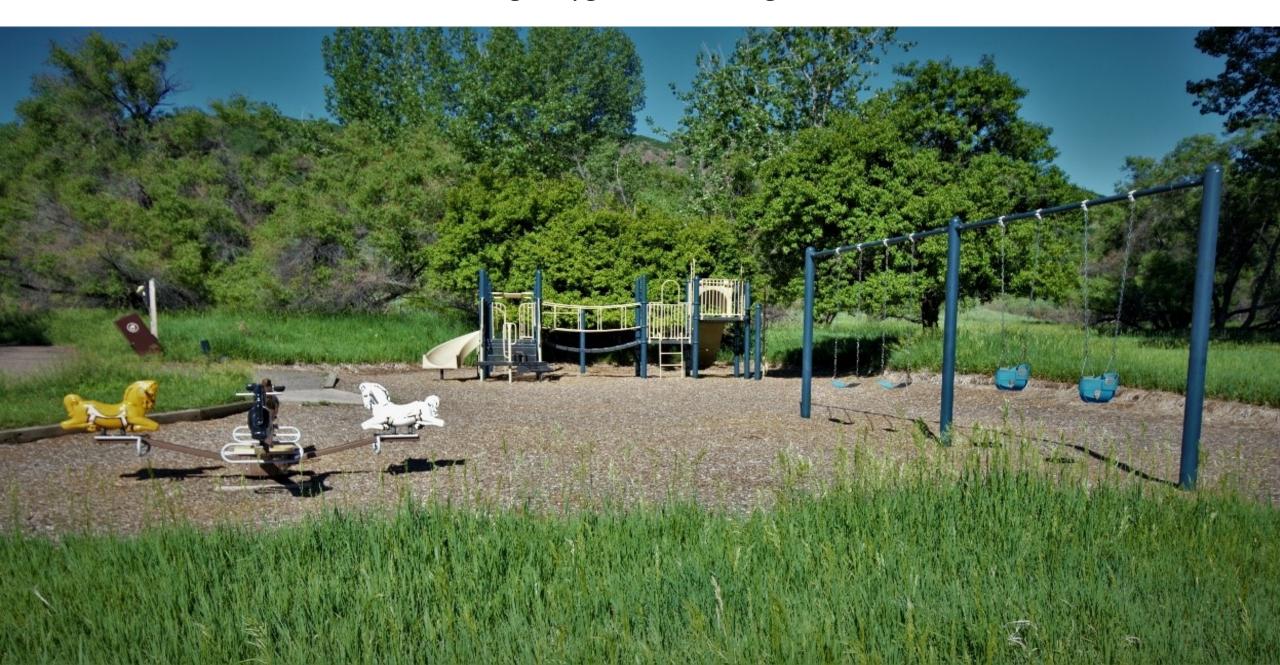
Existing Playground Looking West

- History
 - · Constructed in early 1990's
 - · One of two playgrounds in BGP
- Major Issues
 - In Need of Repair
 - Demographics
 - No Shade
- Reserve Funding
 - 2023
 - · \$82,000

The Task Force recommends the following actions be taken at the playground (See Section 3.0)		
Repair and Upgrade the existing playground area. Estimated Costs: \$39,692	The equipment is over 25 years old and in need of repair. It is primarily geared towards toddlers and younger children. Most of the equipment is extremely hot to the touch and shade should be provided. There is ample space in the center of the existing area to add a new piece of equipment.	
Expand the playground approximately 35 feet to the east. Estimated Costs: \$37,093	Purchase new equipment geared towards older children with a focus on physical fitness. The area should include a (small) climbing wall and other strength and balance equipment. Relocate one of two the picnic tables currently on the eastern edge of the park (near the old playground area) and provide shade.	
Expand the playground to the south between the existing picnic tables. Estimated Costs: \$18,360	This area should be made with natural materials and a few pieces of manufactured equipment. It is envisioned that this would be an Eagle Scout Project and that all of the natural material would be obtained from KCRMA maintenance activities (i.e. tree removal etc.). Finally, it is envisioned that a natural footpath to the pond be established. Also a porta-potty similar to the one near the Bradford Pearly House be located nearby Note: A majority of members believed a porta-potty should be located here. Others felt it should be placed in the parking lot area.

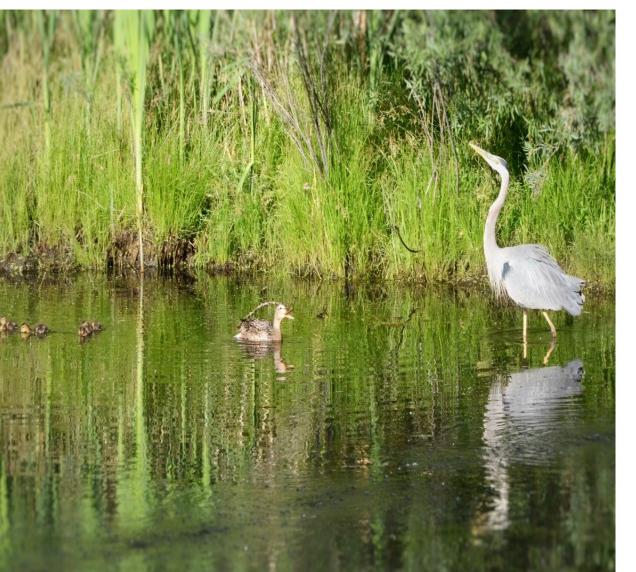
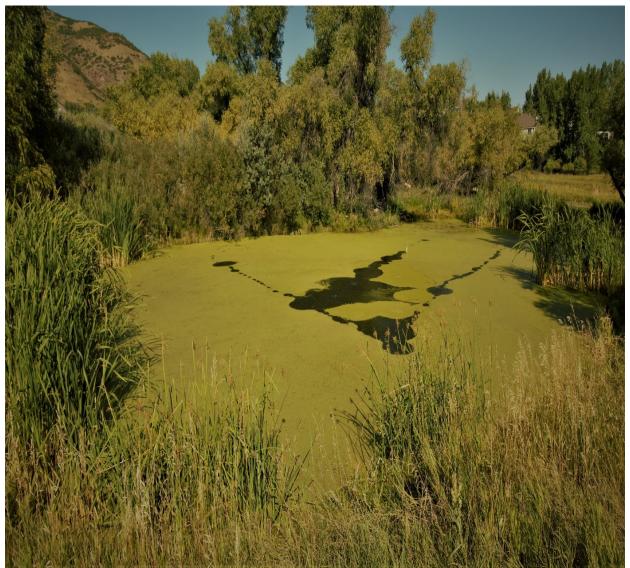
BGP Pond

- Developed in 1950's for Ranching Operations
- 1979 Report to KC Ranch Corporation
- It is one of four open water sources in 10 mile (N/S) area
 - · Mann Reservoir
 - BGP and Dakota Ponds
 - Red Rocks Country Club
- Consistent Usage throughout the years
- Overrun with Cattails and Algae
- Depth has decreased more than 4+ feet since mid 1990's

- Dredge the Pond and Repair Infrastructure
 - Engineering Study to Establish Best Practices
 - Reduce Impact to Groundwater Sources
 - Mitigate Impact to Aquatic Life
 - Define Quantities and Slopes
 - Define Inlet and Outlet Repair Techniques
 - Establish Onsite Sediment Placement Technique and Permits
 - Establish Bid Documents

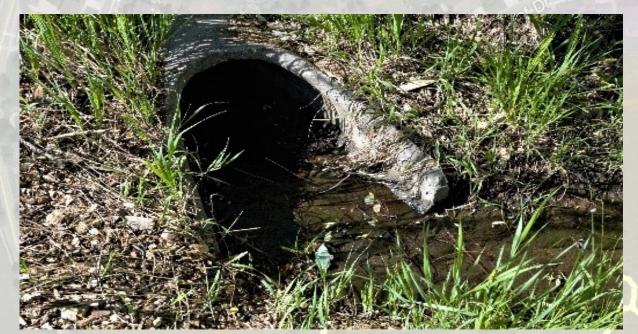
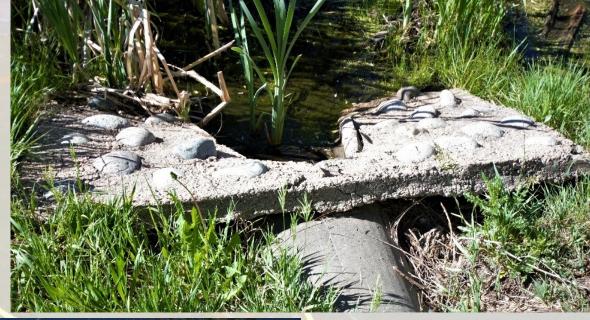
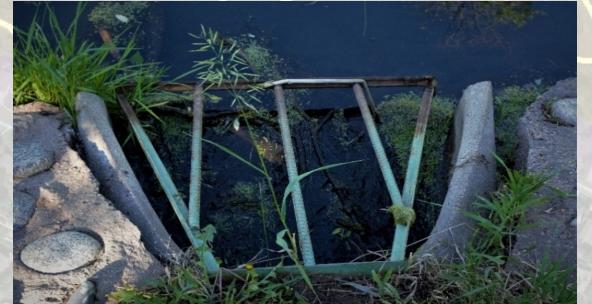
Inlet and Outlet Infrastructure

- Do Nothing
 - Eliminate Microbial Treatment (\$2,200 annual savings and repurpose aeration system)
 - Cattails will eventually consume the pond
 - Marshland with mosquito issues
 - Loss of habitat
 - Loss of Rec Area for residents
- Dredge and Make Basic Infrastructure Repairs
 - Inlet and outlet systems need repair
- Expand Pond, Infrastructure Repairs, add Spillway
 - Similar to Dakota
- Conduct Comprehensive Study
 - · Water Quality and Sediment Sampling
- Breach Pond

Estimated Costs: Included above	recommended that the sediment be placed on-site and hydroseeded. (Note: Offsite disposal costs range between \$40,000 and \$70,000. One member of the Task Force believes the material should be moved off-site regardless of cost differential. See Section 4.4.1).	
Repair the inlet channel, and the inlet & outlet structures.	A precast concrete elbow should be installed to capture water from Massey Draw Creek during high	
Estimated Costs: \$4,090	storm/snow runoff events. The existing inlet & outlet structures need basic concrete repair due to erosio	
Other Perspectives to Consider regarding sediment placement:	Open Space Committee and the Conservation Club
